**DIRECTORATE GENERAL BORDER ROADS**

**GENERAL REPAIR INSTRUCTION NO. 149**

**REPAIR OF BODY CRACK OF BMRR**

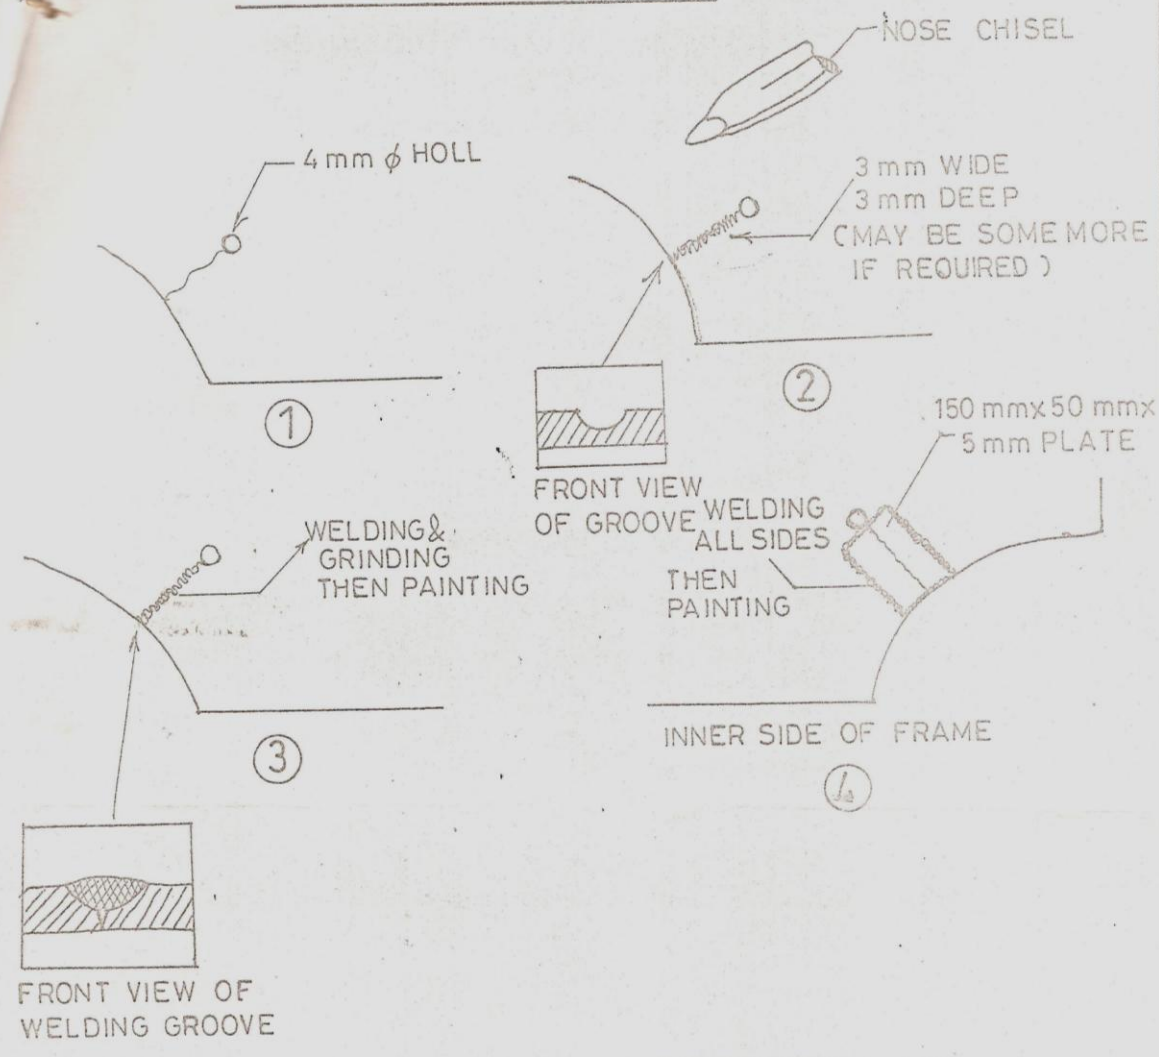
# REPAIRING PROCESS

1. To lay down the procedure of minor repairs of Body crack as generally found vertically about 150 mm long left side of front portion near front roll.

2. Probably, sudden shock load on front roll.

(a) Drill a 4mm O hole at the end of the crack.

(b) Cut a 3mm x 3mm Groove along the crack using a Nose Chisel.

(c) Weld along the Groove using Gas or Arc welding.

(d) Weld one 150mm x 50mm x 5mm plate on the crack at the back side leaving the 4mm O hole free.
